TECHNICAL INFORMATION SHEET

No. 0507-02
2-Aug-05

CINO XS PB Possible damage to Coffee Chute

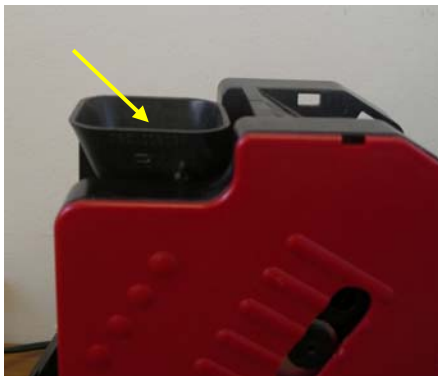
Fig. 1 Coffee Chute

Fig. 1 shows the Coffee Chute and where it is located on the brewer, the part number for it is: 0250008036

If replacing a damaged Coffee Chute, to prevent damage from re-occurring ensure that:
a) The Plunger Rod is fastened securely to the Roll Support, and that b) The Filter Screw is tight.
